CENTRAL VALLEY REGIONAL WATER QUALITY CONTROL BOARD

INSPECTION REPORT

LOCATION & COUNTY: Henry Tosta Dairy
20662 San Jose Road, Tracy
San Joaquin County

INSPECTION DATE: 3 July 2012

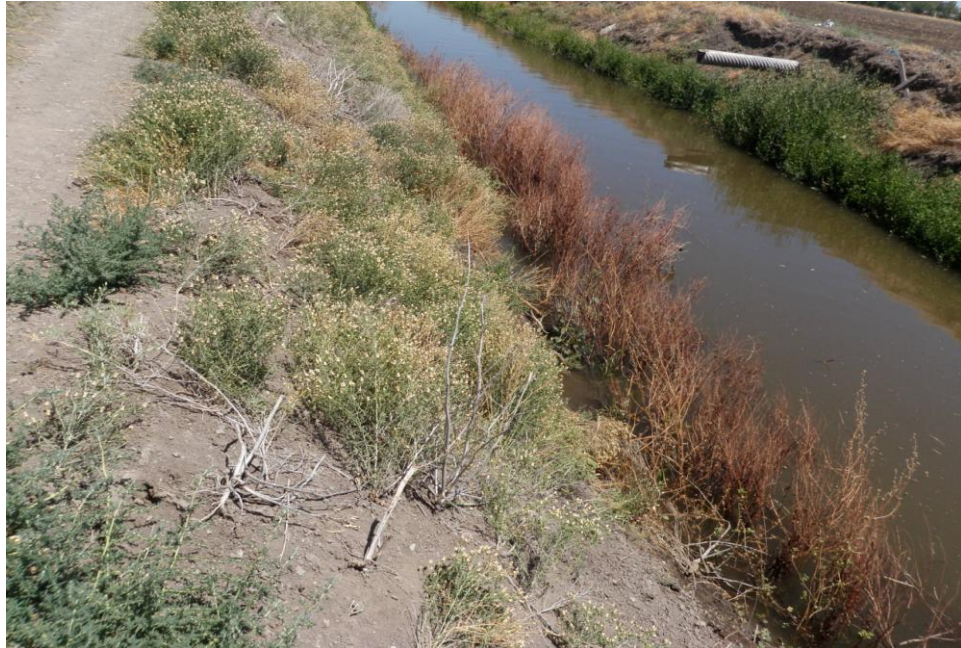
The pipe routed from the Henry Tosta Dairy to the Naglee Burk Irrigation District Drain has been removed. The photo shows the north bank of the drain approximately where the pipe used to be located.

- 1) **DUE 25 JUNE 2012:** Plan for removing manure from the Henry Tosta Dairy production area. Received electronically 5 July 2012.
- 2) **DUE 29 JUNE 2012:** Permanently cap the pipe that is routed from Settling Basin #1 to the Naglee Burk Irrigation District Main canal. Done on or before 29 June 2012. Naglee Burk Irrigation District has confirmed the pipe has been removed. See photo on next page.

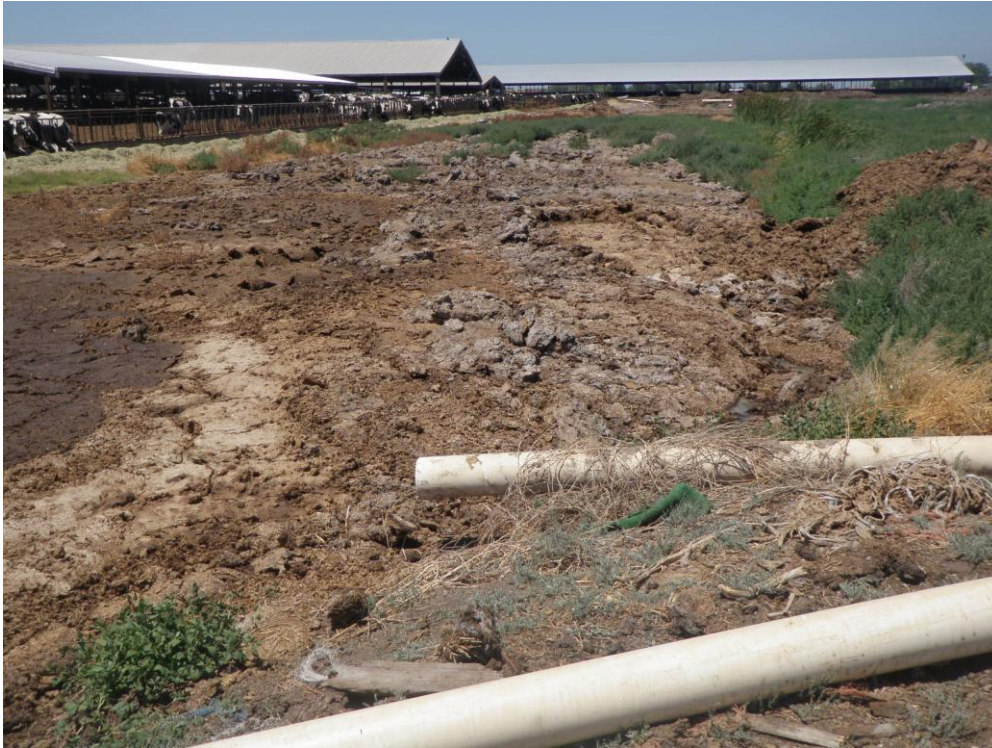
Photo taken 7/3/12: Settling Basin #1 at capacity. No manure or vegetation has been removed from Settling Basin #1.

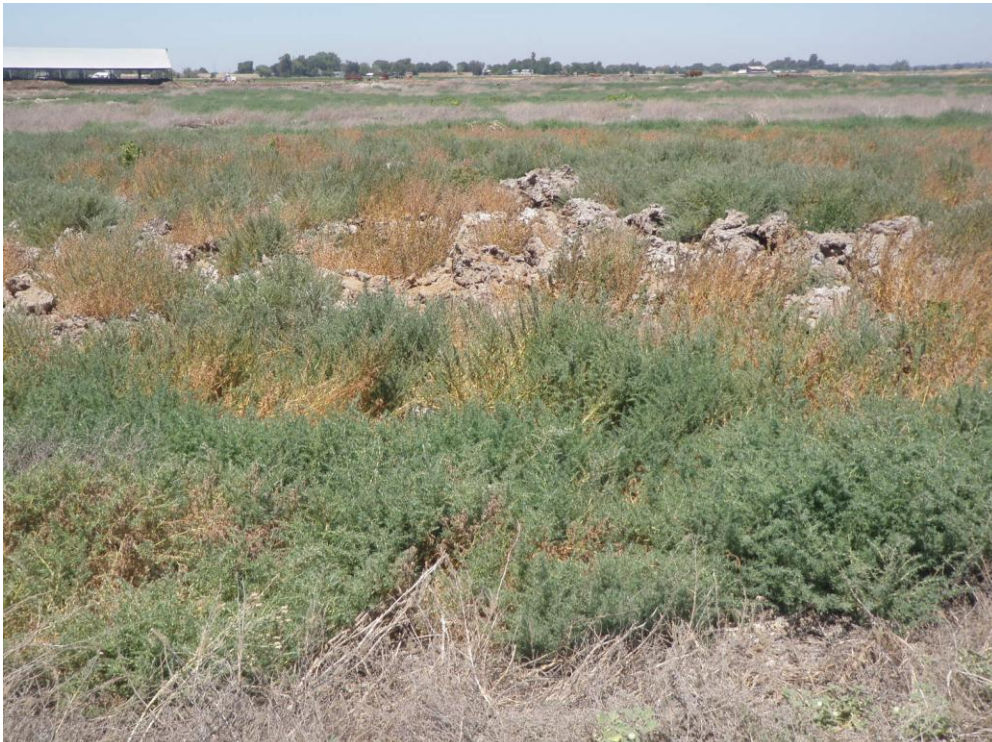
Photo taken 7/3/12: Settling Basin #2 at capacity. No manure or vegetation has been removed from Settling Basin #2.

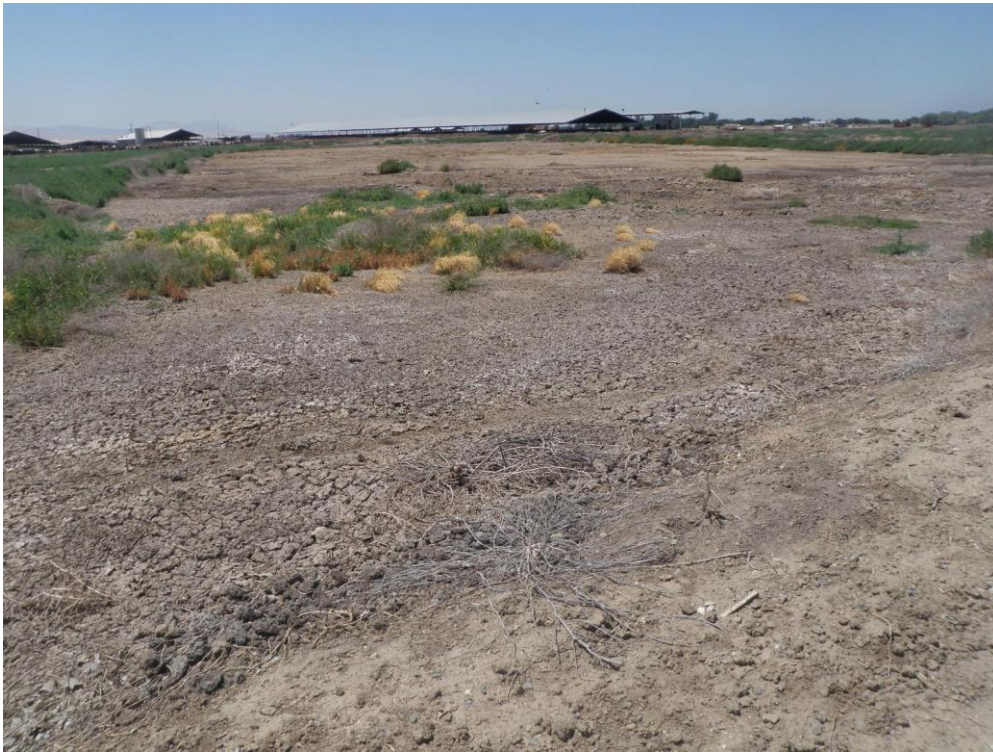
Photo taken 7/3/12: Lagoon #1 – no manure or vegetation has been removed.

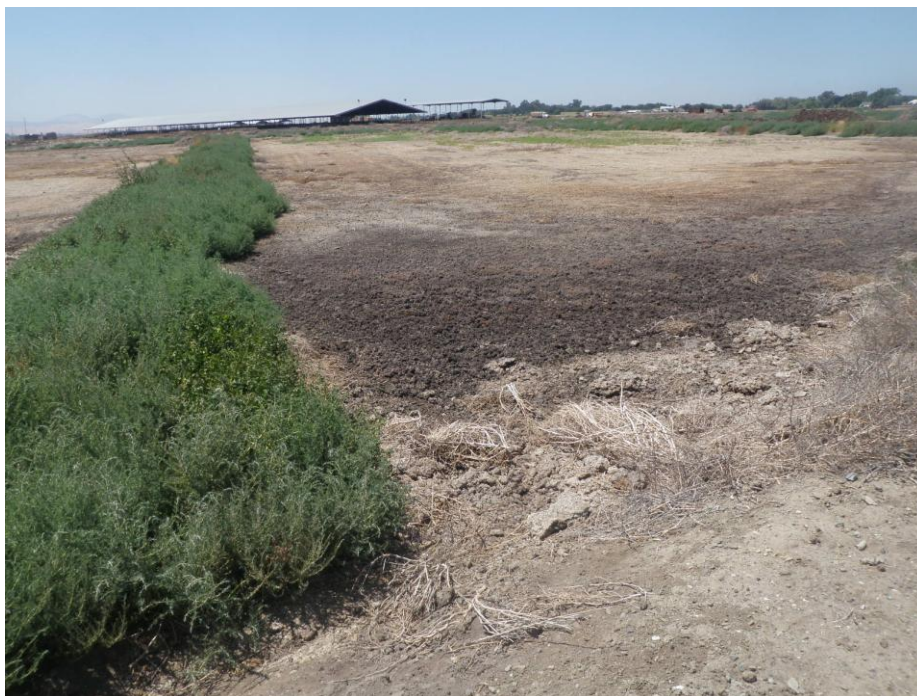
Photo taken 7/3/12: Lagoon #2 – no manure or vegetation has been removed

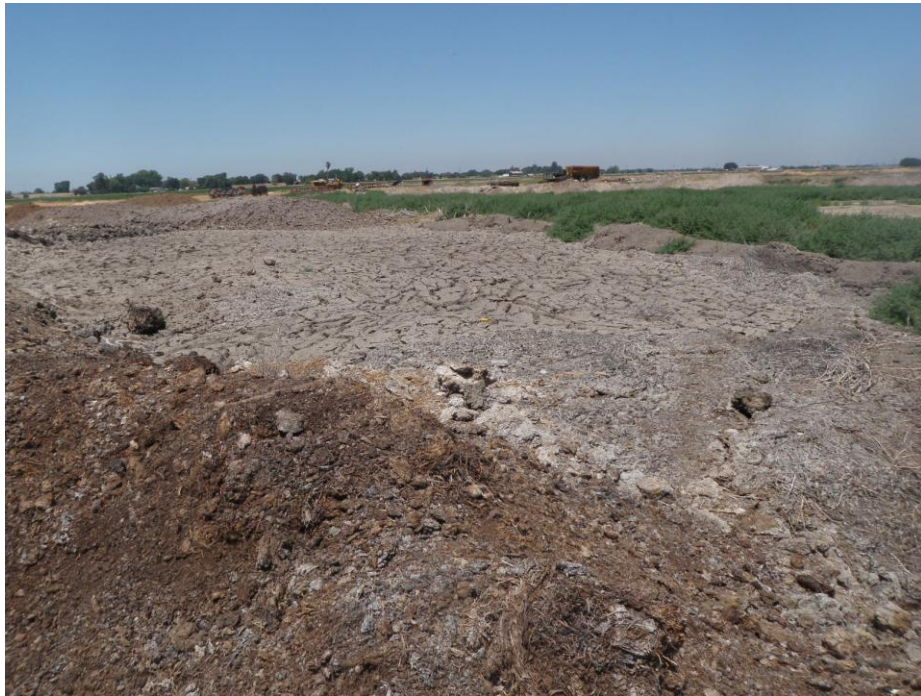
Photo taken 7/3/12: This photo shows a portion of the 3-4 acre area of native soil where massive amounts of solid manure, slurry manure, and wastewater are being stored. No manure has been removed from this area.

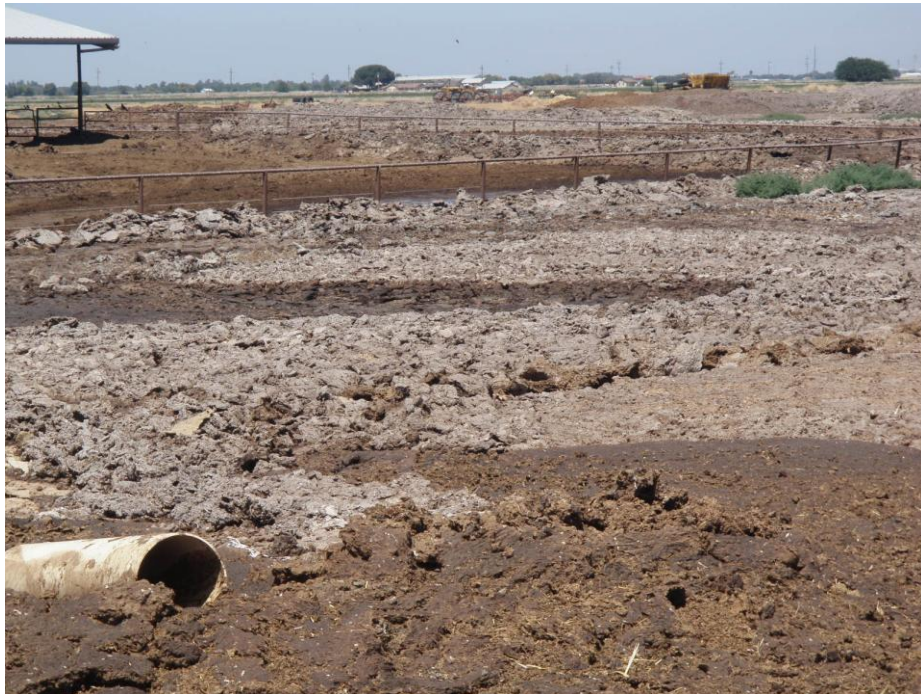
Photo taken 7/3/12: The photo shows a portion of the 3-4 acre area of native soil where massive amounts of solid manure, slurry manure, and wastewater are being stored. No manure has been removed from this area.

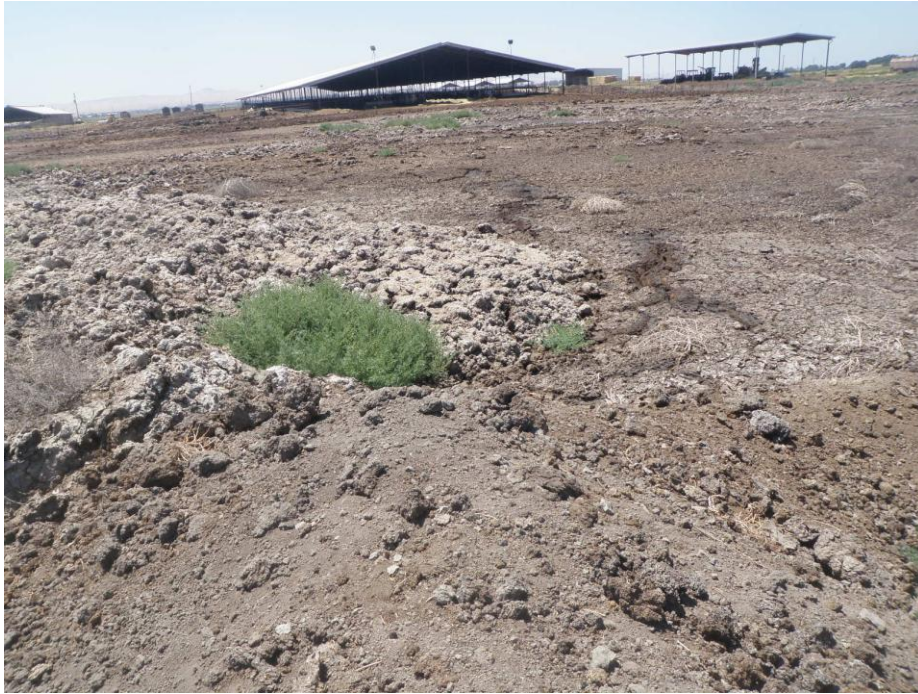
Photo taken 7/3/12: The photo shows a portion of the 3-4 acre area of native soil where massive amounts of solid manure, slurry manure, and wastewater are being stored. No manure has been removed from this area.

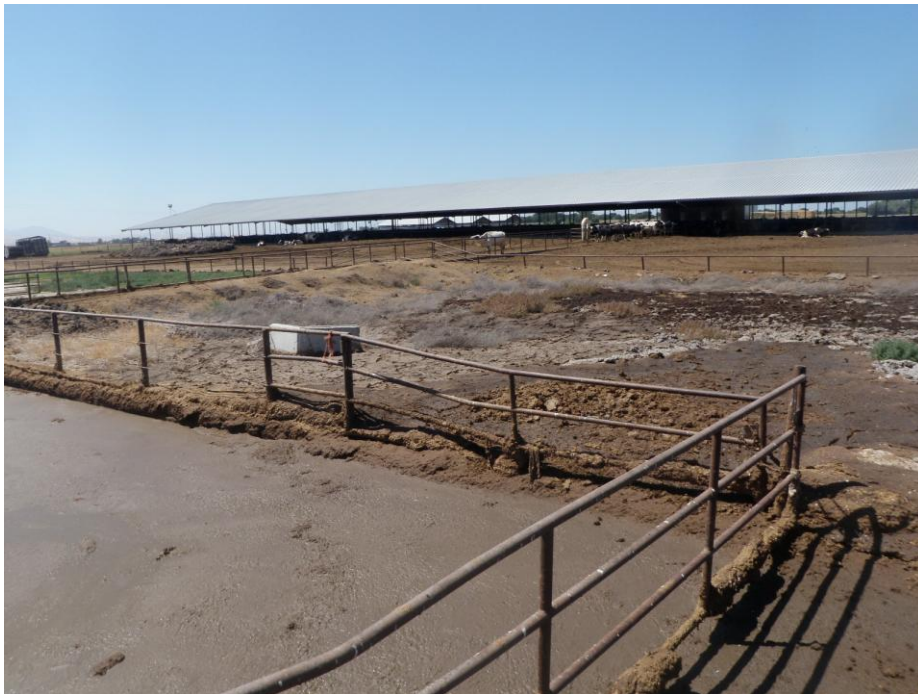
Photo taken 7/3/12: The photo shows a portion of the 3-4 acre area of native soil where massive amounts of solid manure, slurry manure, and wastewater are being stored. No manure has been removed from this area.

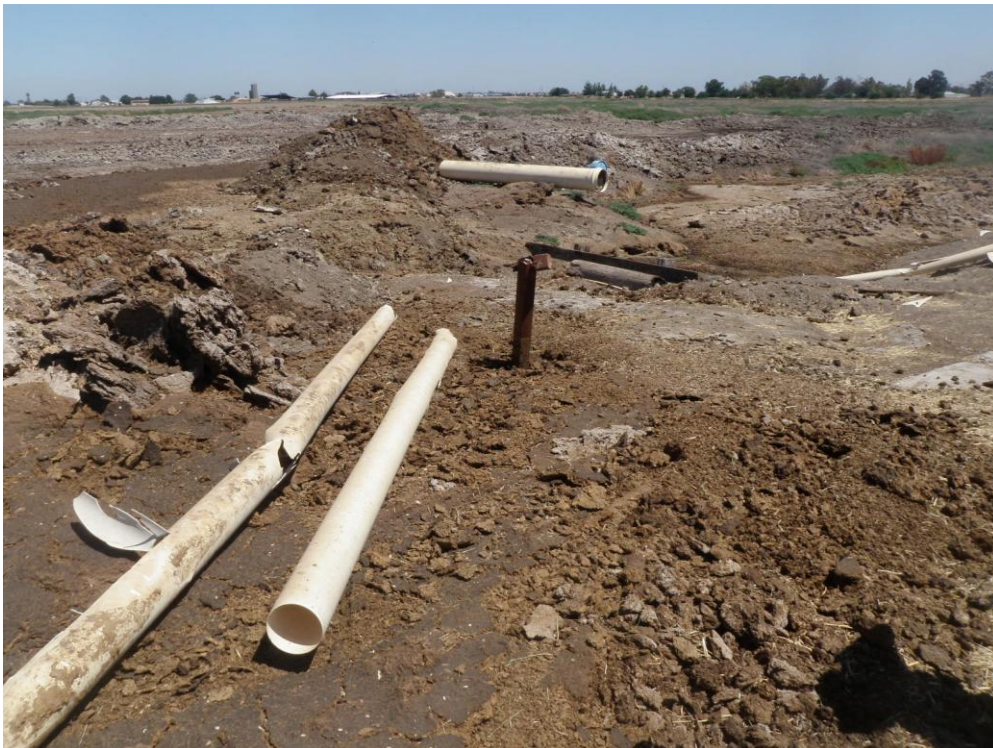
Significant amounts of solid manure, slurry manure, and wastewater are located on top of and adjacent to Monitoring Well #3.

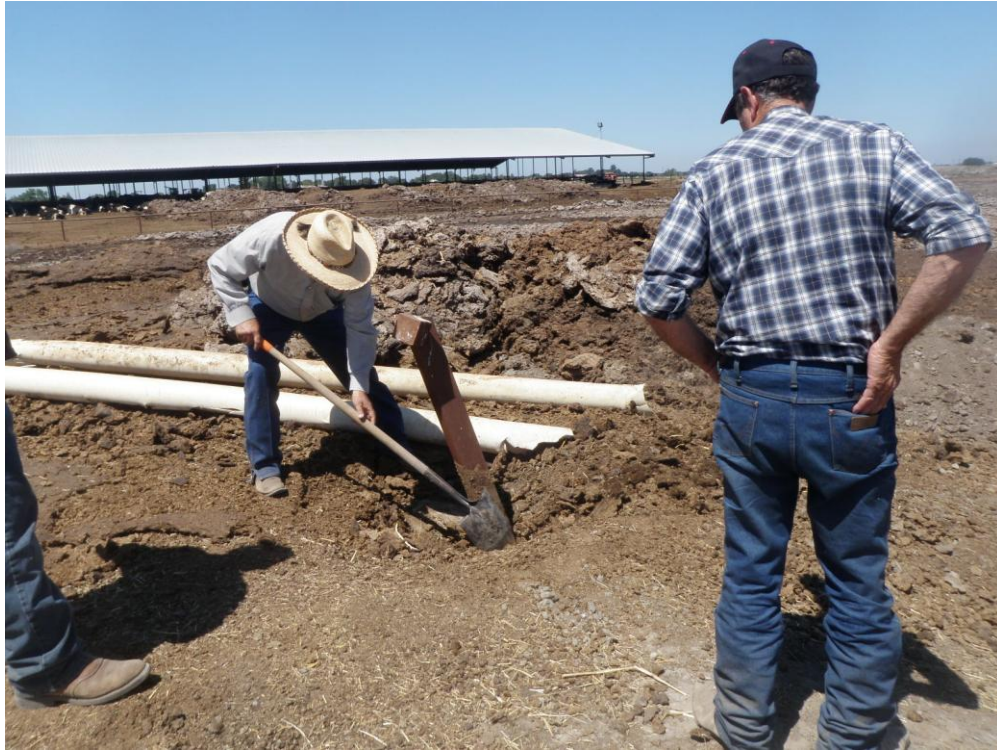
The photo shows David Avila removing solid manure from the top of Monitoring Well #3 so the removable cap could be accessed.

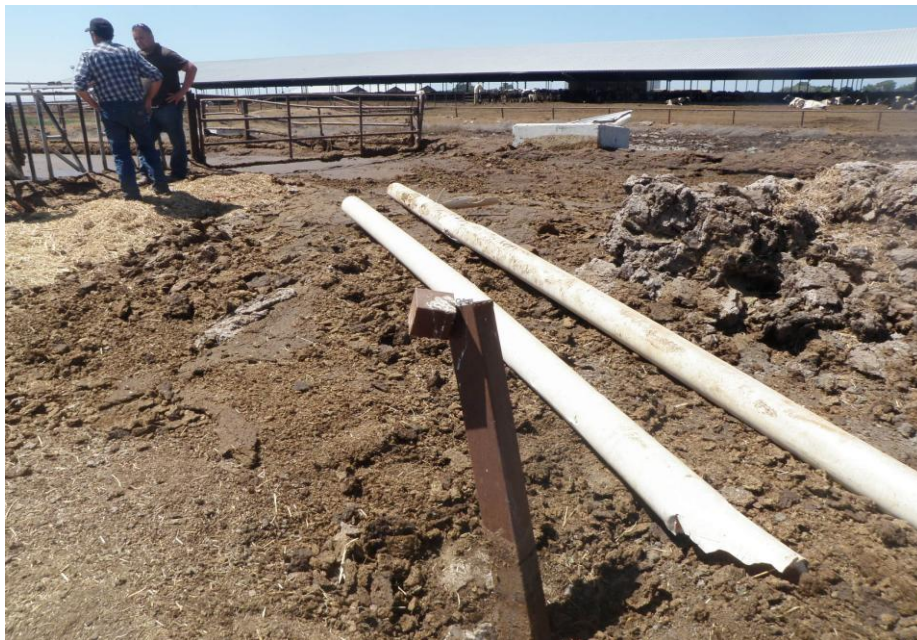
Slurry manure and wastewater that are generated in the production area are pushed through the gated area where they flow on top of and adjacent to Monitoring Well #3.
